Orbiter LH₂ Feedline Flowliner Cracking Problem

NASA Engineering And Safety Center Report	Document #: RP-04-11/ 04-004-E	Version: 1.0
Title: Orbiter LH₂ Feedline Flowliner Cracking Problem Independent Technical Assessment (ITA) Report			Page #: 1 of 132

In May of 2002, three cracks were found in the downstream flowliner at the gimbal joint in the LH₂ feedline at the interface with the Low Pressure Fuel Turbopump (LPFP) of Space Shuttle Main Engine (SSME) #1 of Orbiter OV-104. Subsequent inspections of the feedline flowliners in the other orbiters revealed the existence of 8 additional cracks. No cracks were found in the LO₂ feedline flowliners. A solution to the cracking problem was developed and implemented on all orbiters. The solution included weld repair of all detectable cracks and the polishing of all slot edges to remove manufacturing discrepancies that could initiate new cracks. Using the results of a fracture mechanics analysis with a scatter factor of 4 on the predicted fatigue life, the orbiters were cleared for return to flight with a one-flight rationale requiring inspections after each flight. OV-104 flew mission STS-112 and OV-105 flew mission STS-113. The post-fli

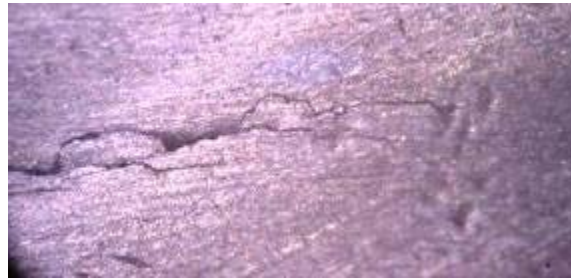
Figure 5.0-5. Crack Bifurication

- e. Some cracks exhibited bifurcation (see Figure 5.0-5).

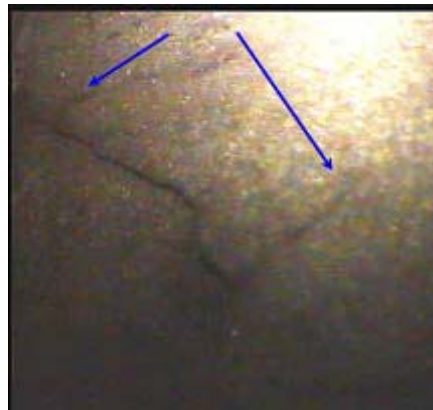
Figure 5.0-6. Crack Branching

- f. Some cracks exhibited branching (see Figure 5.0-6).

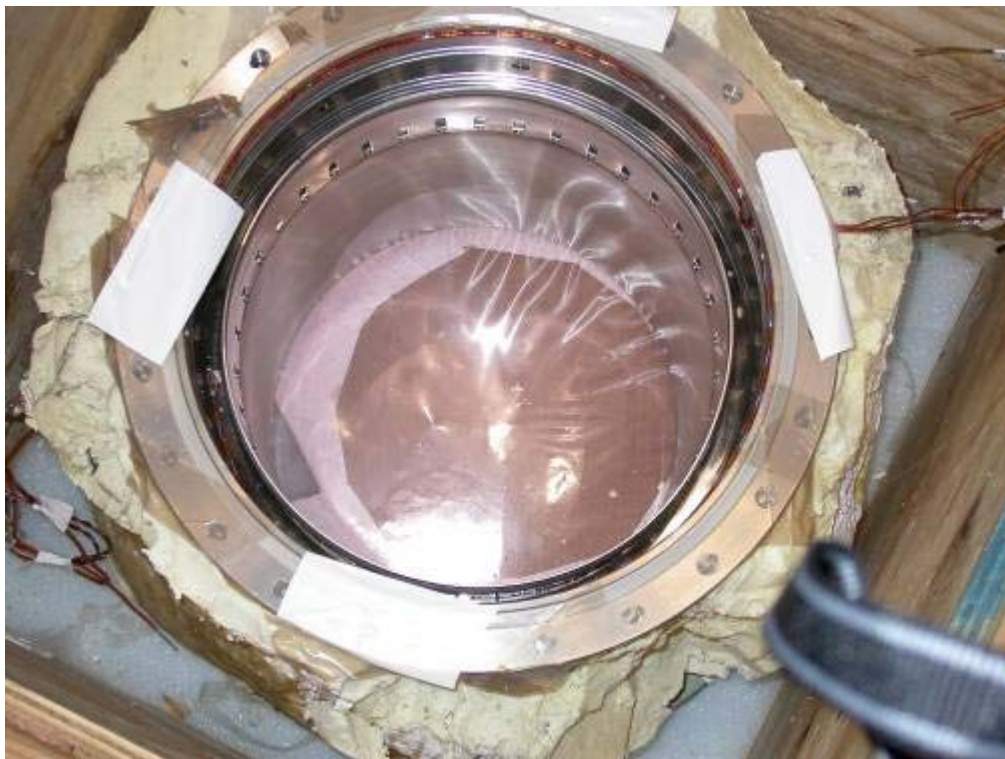
Figure 7.1.3-2. Upstream Half of the BTA

In contrast to the GTA, the BTA was fabricated at Stennis Space Center, where the interior dimension is routinely machined to an inner diameter of 12.07 inches. Thus, this machining removed the weld beads that joined the end flanges to the test article. The upstream half of the test article can be seen in Figure 7.1.3-2 which shows a smooth surface from the upstream end of the test article to the small weld bead at the flowliner attachment.
